Track Control arm
BMW (E36)

Sidem Nr.
21370 R
21371 R

Reference nr.
31 12 6 758 513
31 12 6 758 514

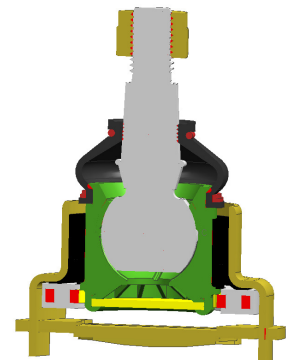
Original:

- Early wear of rubber bedding Ball Joint.
- Play on ball joint.

- Weak connection by rubber between inner and outer bushing.
- When replacing a ball joint, special equipment is needed to press it in the arm to prevent damage.
- Damaged dustcover.
