**Track control arm
Audi**

Sidem Nr.	Reference nr.
37672/73	8E0 407 505/6 P
37670/71	4D0 407 509/10 K
37972/73	8E0 407 509/10 P
37070/71	8K0 407 509/10 A
37078/79	8K0 407 505/6 A

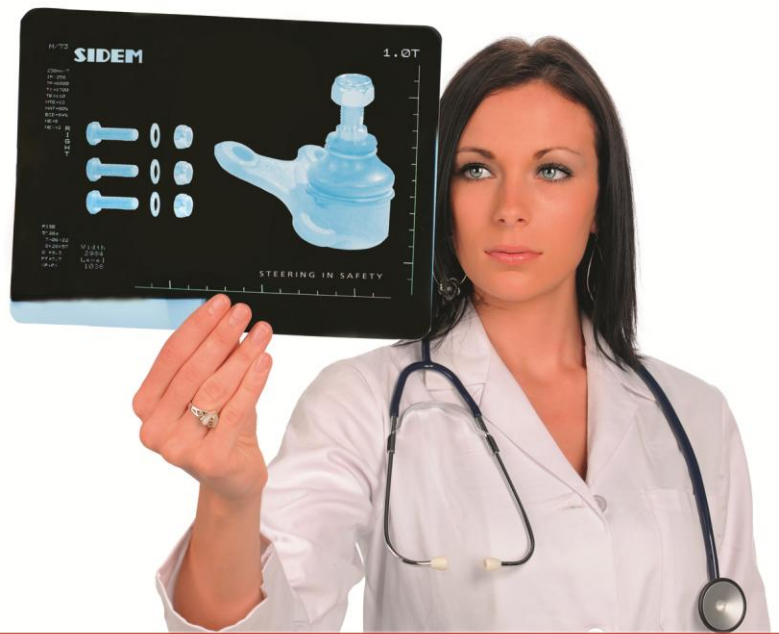
Original:

- Play on Ball joint

- Due to its location, the track control arms are exposed to all kind of external influences. When a dustcover is damaged or is not fitting perfectly, water and dirt finds its way into the joint. This causes oxidization of the ball pin, which leads to wear of the plastic cup.
