Track Control arm
BMW (E46)

21278 R

21279 R

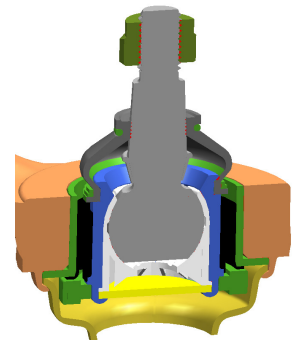
Original:

- Early wear of rubber bedding Ball Joint.
- Play on ball joint.

- Weak connection by rubber between inner and outer bushing.
- Damaged dustcover.
