Sidem Nr.	Reference nr.
Track Control arm	21972 R	31 12 6 758 513 S1
BMW (E36)	21973 R	31 12 6 758 514 S1

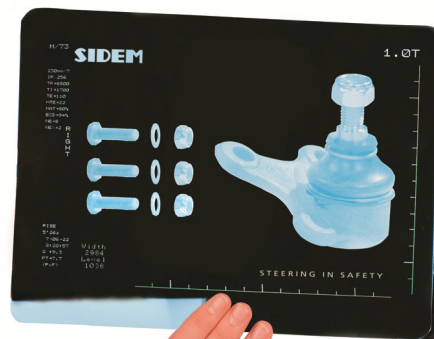
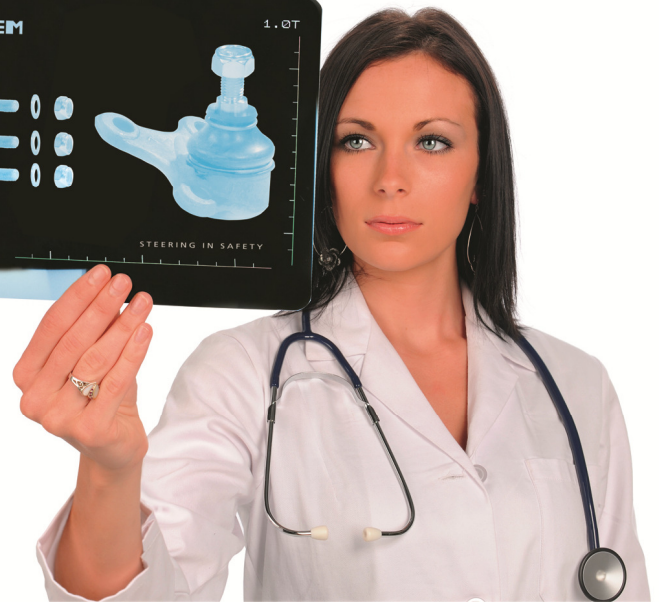
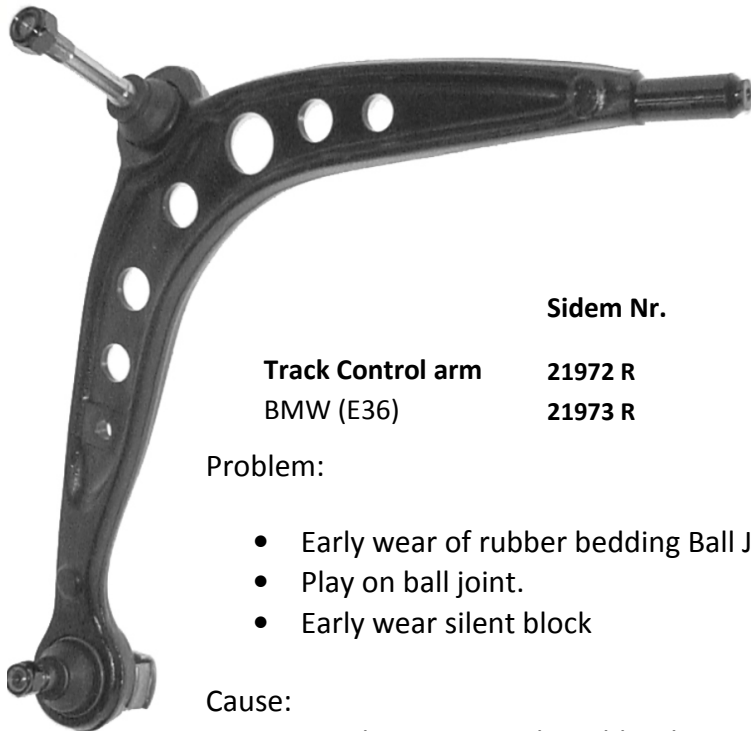
- Early wear of rubber bedding Ball Joint.
- Play on ball joint.
- Early wear silent block

- Weak connection by rubber between inner and outer bushing.
- When replacing a ball joint, special equipment is needed to press it in the arm to prevent damage.
- Damaged dustcover.
- Wrong method of mounting silent block.

! When the arm with rubber bedding is replaced by the improved version, replace both left and right arm !

- A new ball joint is progressed without the rubber core.
- A cover is added to protect the pin and the dustcover during transport and storage.
- A document is added with mounting tips.
