Sidem Nr	OE Number
Mercedes	49976	204 330 43 11
Track Control Arm	49977	204 330 44 11
	49978	204 330 19 11
	49979	204 330 20 11

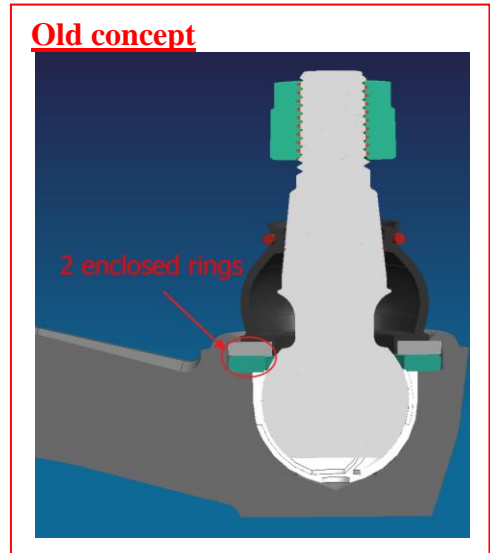
- Premature play on ball-joint.

- Due to the 2 enclosed rings that close the assembly, tolerances cannot be kept as small.
- This can cause instability-play in extreme conditions.
