**Audi
Track control arm**

Sidem Nr.	Reference nr.
37675	4D0 407 151 P

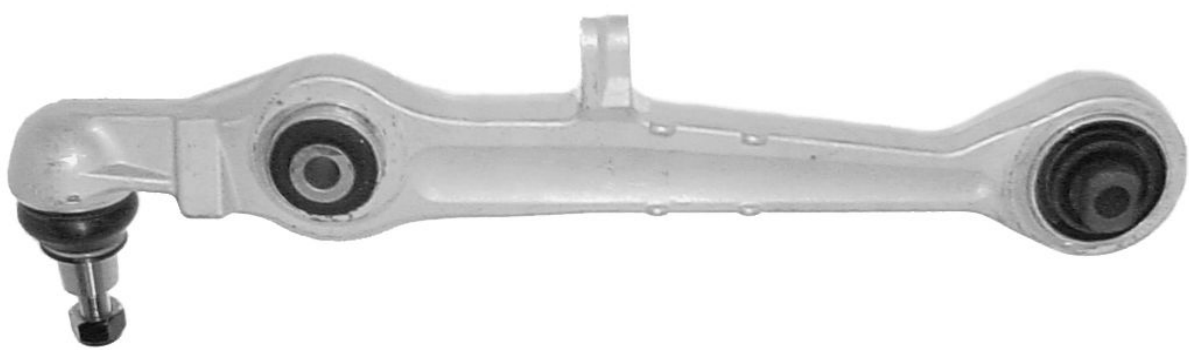
Original:

- Play on Ball joint

- Water infiltration in the ball joint gives early wear.
- Bad closure of the dustcover.
- Unprotected surface of the cone is causing early forming of rust.
