Mounting advise for ball joints with heat shield

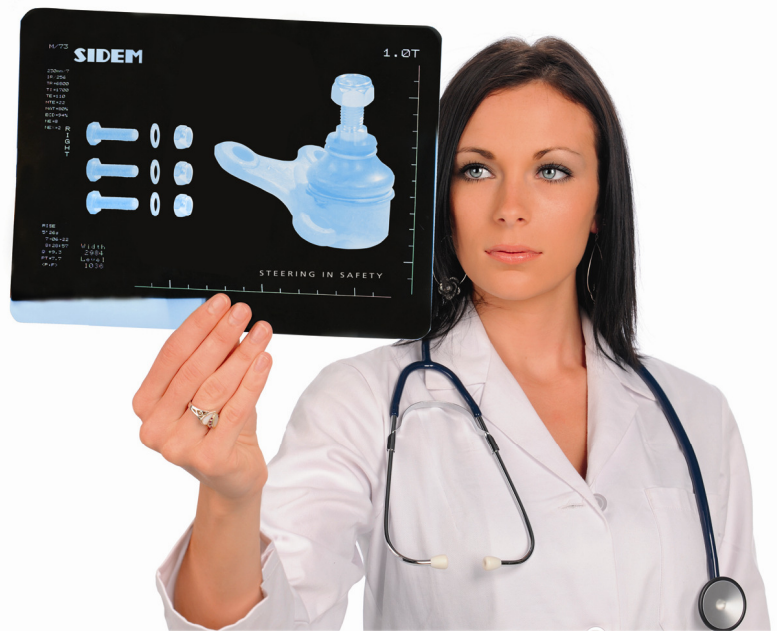
- Grease gets too hot
- Infiltration of water or dirt on top of dustcover

- Heat shield damaged during replacement of the ball joint
- Heat shield is too corroded and broken

- Always reinstall the heat shield when there's an original one from the constructor. The heat shield protects the grease of the ball joint against high temperatures of the brake disc.
- Always install a new shield when it's corroded. Especially if the top of the dustcover connects with the heat shield.

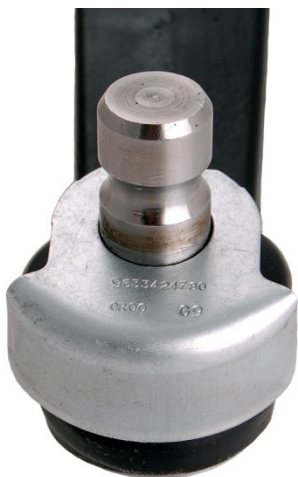
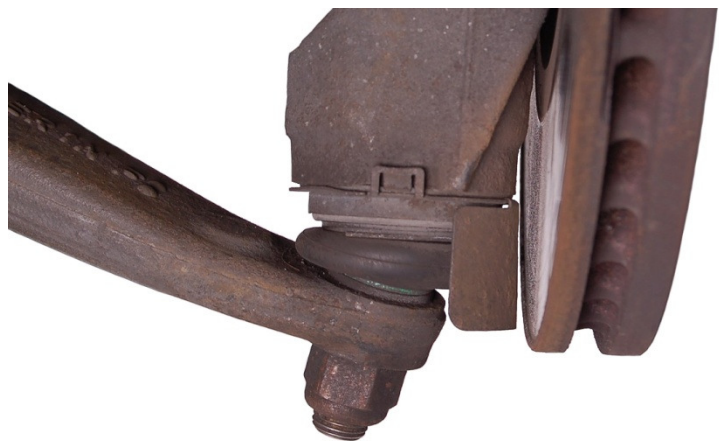
Heat shields occur on cars with ball joints with cylindrical pins on brands like Citroën, Dacia, Ford, Mazda, Nissan, Peugeot, Renault,...
