**Mercedes  
Ball Joint**

**Sidem Nr.  
49383**

**Reference nr.  
211 330 03 35**

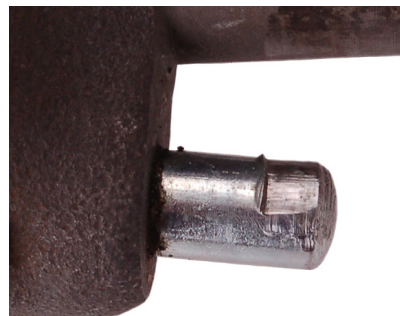
**Original:**

**Problem:**

- Difficult mounting
- Location of “positioning pin” is not OK.
