## Mounting advise for ball joints with protection plate

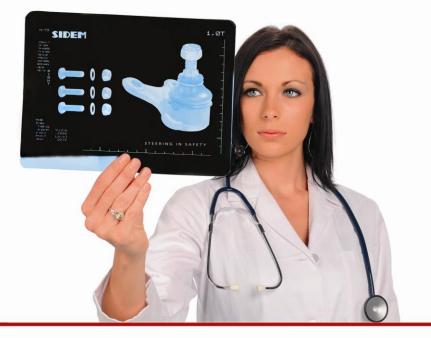
- Infiltration of water or dirt on top of dustcover
- Wear of the top of the dustcover, by turning against a rough surface

• Protection plate for top DC is not fitted

- The protection plate creates a smooth surface for the top of the dustcover, making sure that the top of the dustcover seals perfectly against this plate.
- Always install the protection plate when there's an original one from the constructor. The protection plate protects the top of the dustcover for wear.
- If there's a clip on it be sure to fit it always in the notch in the steering knuckle, so the protection plate stays in place.

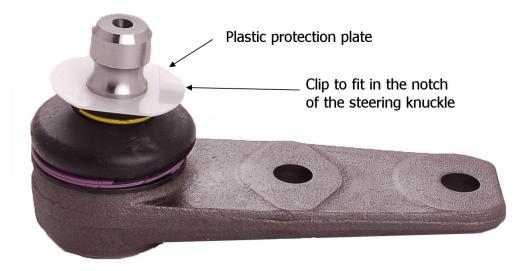
Protection plates occur on cars with ball joints with cylindrical pins mainly on Renault applications.
