6534

6535

Renault-Opel-Vauxhall-Nissan Tie Rod End **OE Number** 48520 00QAK 48520 00QAL

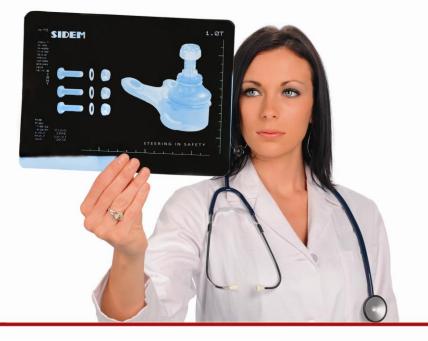
Old design

Undercut where the top of the Dust Boot can slide in.

Possibility of shooting the top of the DC in the neck while installing the Tie Rod End

• Neck on ballpin without mechanical seat

The neck on the ballpin is removed on The ballpin, so no possibility anymore for the DC to shoot in the neck
