# SIDEM SOLUTIONS

## Improved track control arm Audi, Seat, Skoda and Volkswagen

SIDEM	APPLICATION	N° OE
37672/73	track control arm	Audi A4/S4/A6, Seat Exeo, Skoda Superb, VW Passat	8E0 407 505/6 P
37670/71			4D0 407 509/10 K
37972/73			8E0 407 509/10 P
37070/71			8K0 407 509/10 A
37078/79			8K0 407 505/6 A

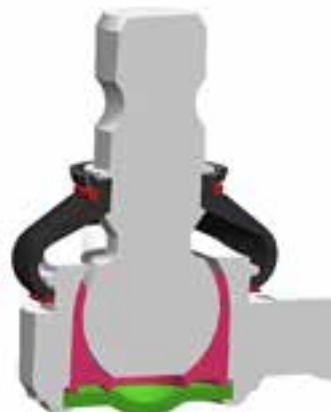
- Play on ball joint

- Due to its location, the track control arms are exposed to all kind of external influences. When a dustcover is damaged or is not fitting perfectly, water and dirt finds its way into the joint. This causes oxidization of the ball pin, which leads to wear of the plastic cup.

- A new dustcover is designed with a perfect fit along the rod.
- A new rod is designed with a improved neck shape to ensure tight closing of the dustcover during movement.
