Track Control arm
BMW (E36)

Sidem Nr.
21370 R
21371 R

Reference nr.
31 12 6 758 513
31 12 6 758 514

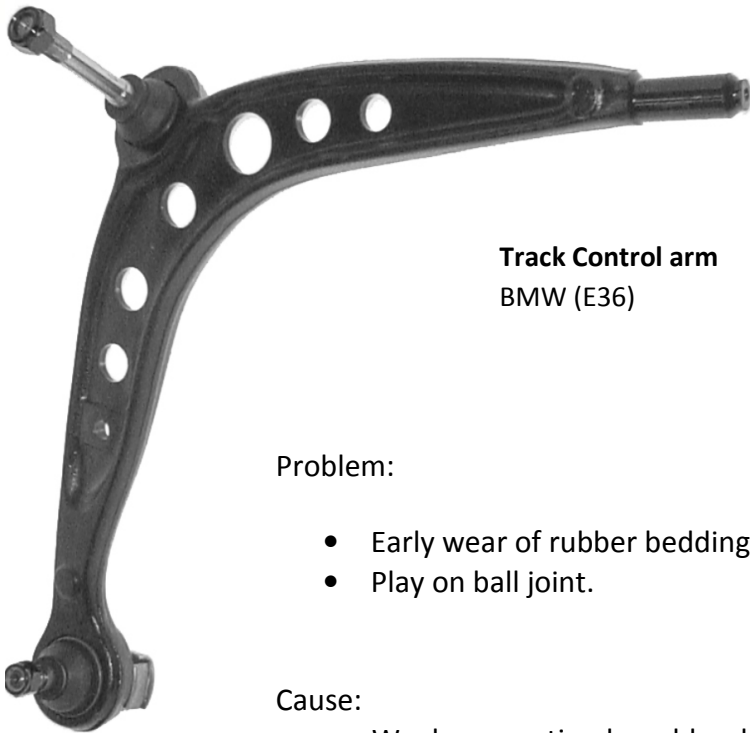
- Early wear of rubber bedding Ball Joint.
- Play on ball joint.

- Weak connection by rubber between inner and outer bushing.
- When replacing a ball joint, special equipment is needed to press it in the arm to prevent damage.
- Damaged dustcover.

! When the arm with rubber bedding is replaced by the improved version, replace both left and right arm !

- A new ball joint is progressed without the rubber core.
- A cover is added to protect the pin and the dustcover during transport and storage.
