Track Control arm
BMW (E46)

21278 R

21279 R

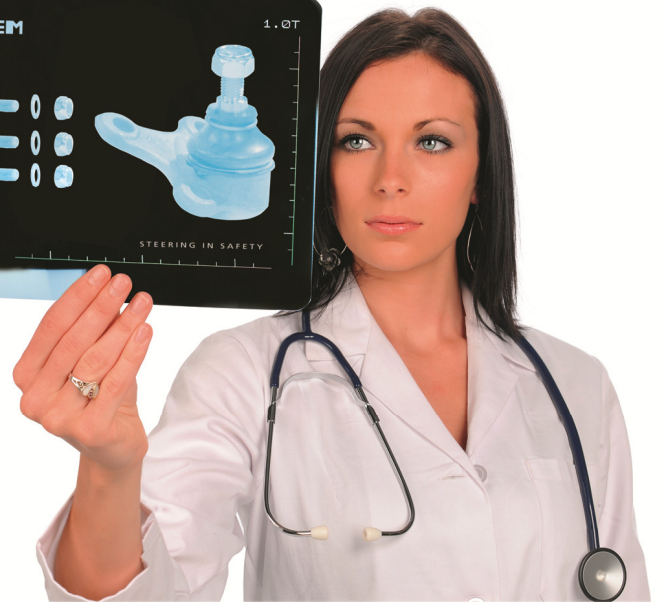
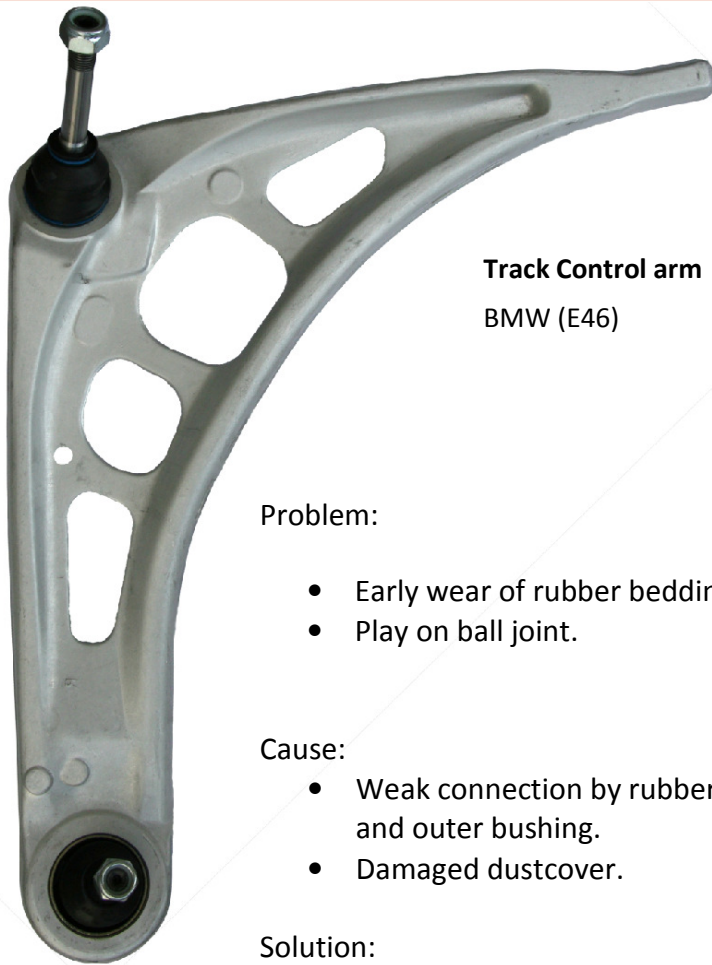
- Early wear of rubber bedding Ball Joint.
- Play on ball joint.

- Weak connection by rubber between inner and outer bushing.
- Damaged dustcover.

- A new ball joint is progressed without the rubber core.
- A cover is added to protect the pin and the dustcover during transport and storage.

! When the arm with rubber bedding is replaced by the improved version, replace both left and right arm !
