Sidem Nr.	Reference nr.
Track Control arm	21972 R	31 12 6 758 513 S1
BMW (E36)	21973 R	31 12 6 758 514 S1

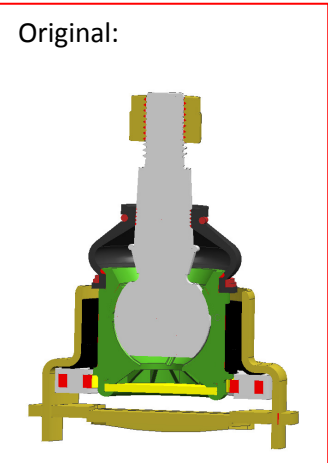
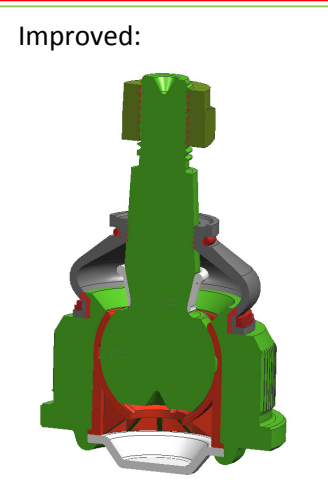
- Early wear of rubber bedding Ball Joint.
- Play on ball joint.
- Early wear silent block

- Weak connection by rubber between inner and outer bushing.
- When replacing a ball joint, special equipment is needed to press it in the arm to prevent damage.
- Damaged dustcover.
- Wrong method of mounting silent block.

! When the arm with rubber bedding is replaced by the improved version, replace both left and right arm !

- A new ball joint is progressed without the rubber core.
- A cover is added to protect the pin and the dustcover during transport and storage.
- A document is added with mounting tips.
