Sidem Nr	OE Number
Mercedes	49976	204 330 43 11
Track Control Arm	49977	204 330 44 11
	49978	204 330 19 11
	49979	204 330 20 11

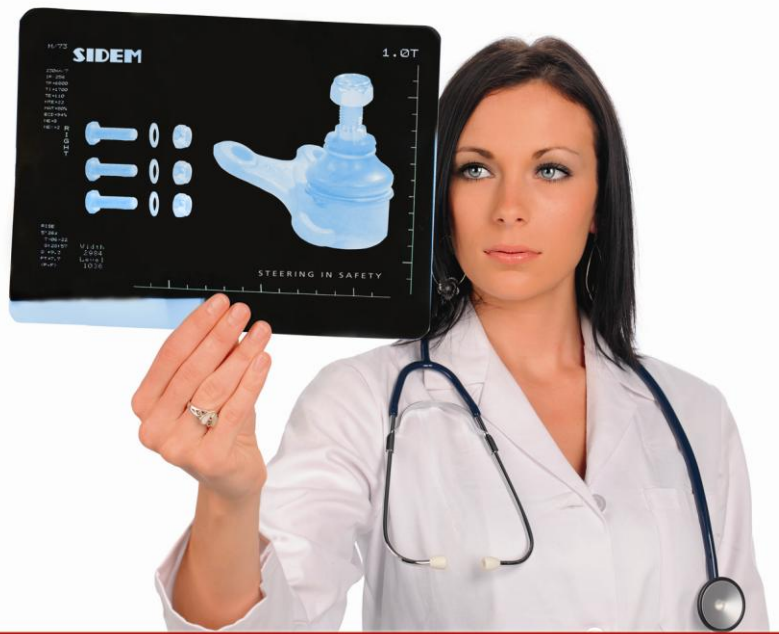
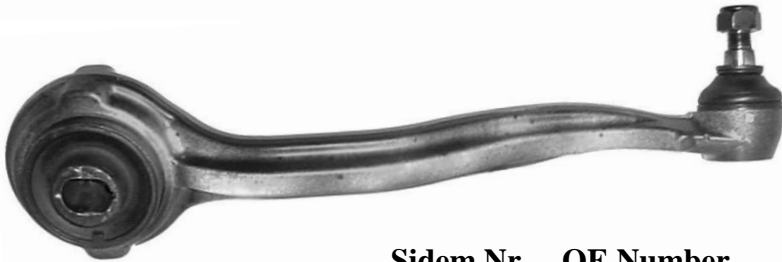
- Premature play on ball-joint.

- Due to the 2 enclosed rings that close the assembly, tolerances cannot be kept as small.
- This can cause instability-play in extreme conditions.

- Classic design with only 1 enclosed ring where the DC is attached on a classical way
- So the closing ring is in direct contact with the insert what offers a more stable-rigid assembly.
