Improved track control arm Audi, Skoda & Volkswagen

SIDEM	TOEPASSING	N° OE
37675	track control arm	Audi A4/S4	4D0 407 151 P
		Audi A6	
		Audi A8	
		Skoda Superb	
		VW Passat IV/V

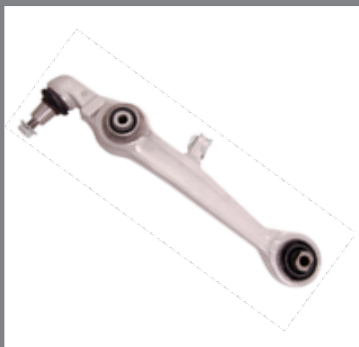
- Play on ball joint

- Waterinfiltration in the ball joint by not sufficient sealing of the dustcover.

- A new dustcover is designed with a perfect fit along the rod.
- A new balpin is designed with an improved neck shape to ensure tight closing of the dustcover during movement.
